# Disaster Resilience of Indira Awaas Yojana Houses

*- Pilot study in six states*

2012

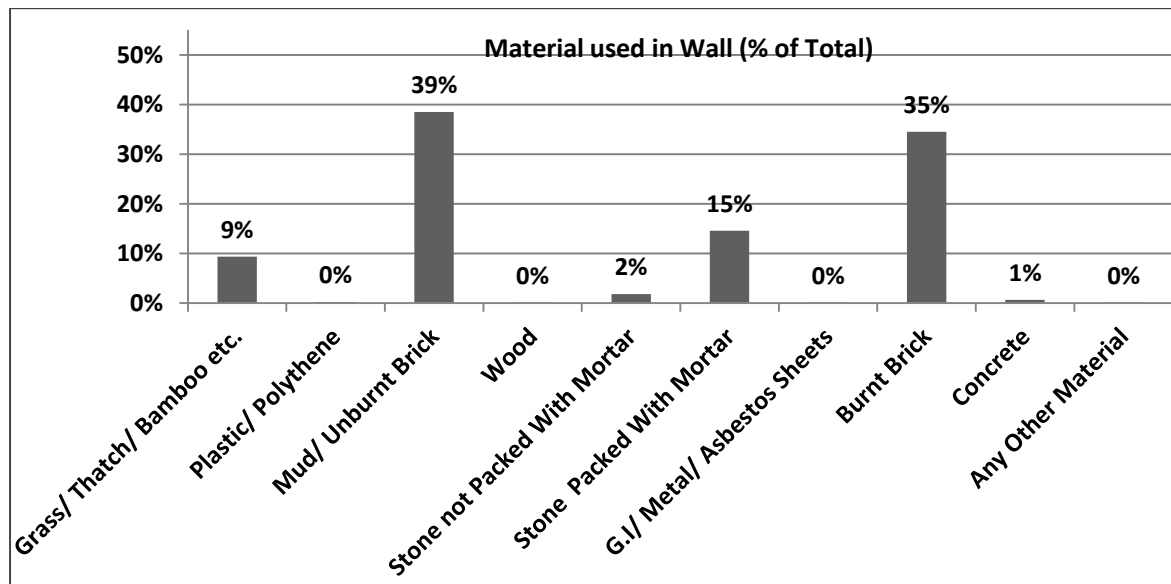
### Material used for walling

The predominant materials used are mud or unburnt bricks, secondly burnt bricks are used, followed by stone, packed with mortar which was also found to be common.
